**Flood Control Project Maintenance
Levee Inspections**
LMA District Cover Sheet
Spring 2017 Levee Inspection Results

Reclamation District No. 1600 Mull

Spring 2017 Levee Inspection Results

| Waterway | | | Bank | Unit Miles |
|--|---|---|---|---|
| Unit No. 01 Sacramento River | | | Right | 10.46 |

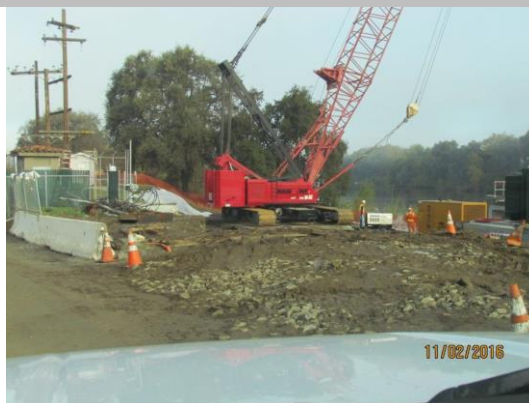
Photo 2 of 3 : SP_2017_RD1600_191_1_20170320_00002.jpg

Building was removed due to a new construction. Fall 2016.

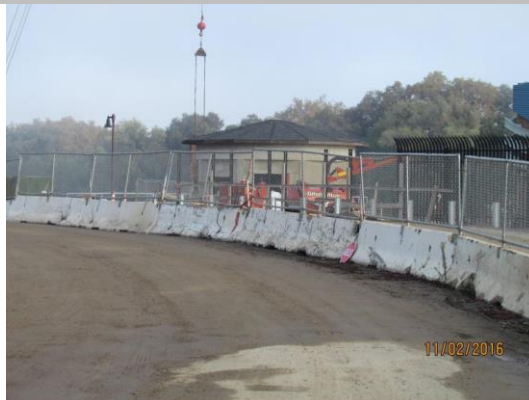
Photo 3 of 3 : SP_2017_RD1600_191_1_20170320_00003.jpg

View of a new pumping plant construction. Fall 2016.

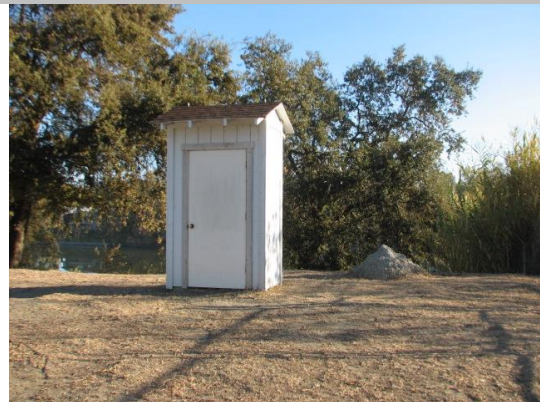
Photo 1 of 2 : SP_2017_RD1600_191_129_20170320_00080.jpg

| This is a well pump house. It is potable water for the house and pumping plant. | | | | | |

The small building is a pump house for the well. It services the house with water. Fall 2013

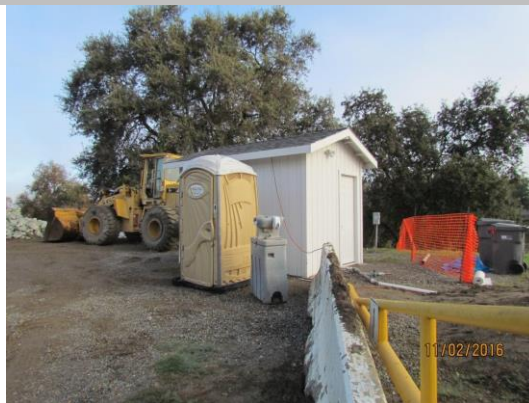
Photo 2 of 2 : SP_2017_RD1600_191_129_20170320_00081.jpg

| This is a well pump house. It is potable water for the house and pumping plant. | | | | | | |

Updated view of the building. Fall 2016.

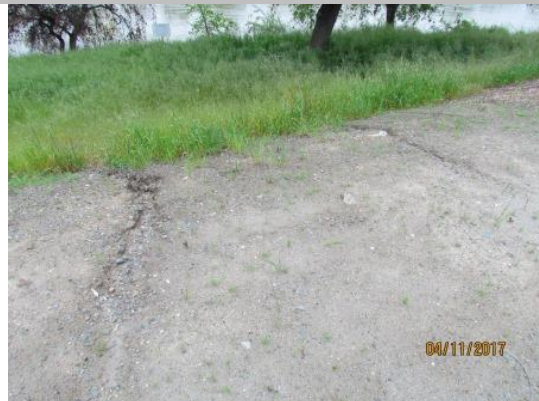
Photo 1 of 1 : SP_2017_RD1600_191_46_20170413_00125.jpg

| Two small rills on waterside levee slope. | | | | | |

Rills from runoff on waterside levee slope. Spring 2017.

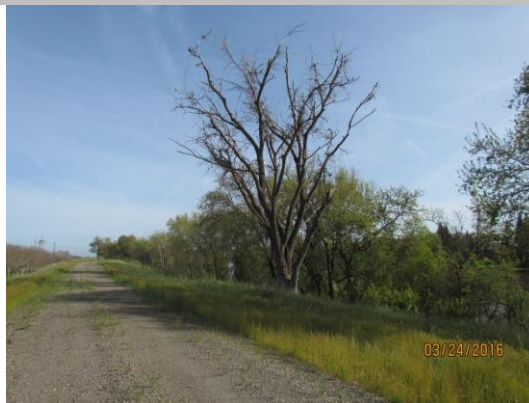
Photo 1 of 2 : SP_2017_RD1600_191_624_20170320_00088.jpg

| The tree is dying and needs to be monitored. | | | | | |

View of the dying tree on the waterward side of the levee looking upstream. Spring 2016.

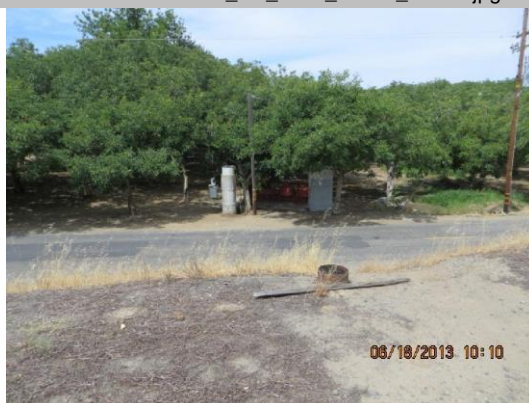
Photo 1 of 3 : UCIP_SP_2017_15285_25088.jpg

| FS_ID:15285 DS_ID:21463 EP_NO: 6100 Repair Type: Non-Urgent Crossing Status: Found UCIP Comments: Gate valve will not open or close. FIELD_STRUCT_DESC: 12-inch pipe through levee 3.4 feet below crown. Slant pump and gate valve on the waterward- slope. Siphon breaker in 12-inch steel riser on the landward shoulder. Filter, booster pump, and butterfly valve on LS toe. 2.25-inch galvanized iron electrical conduit at same location (Permit No. 6100, 1968). Replaced 8-inch pipe at same location. FS Date: 6/18/2013 | | | | | |

Siphon breaker in steel riser on LS shoulder and concrete standpipe off LS toe.

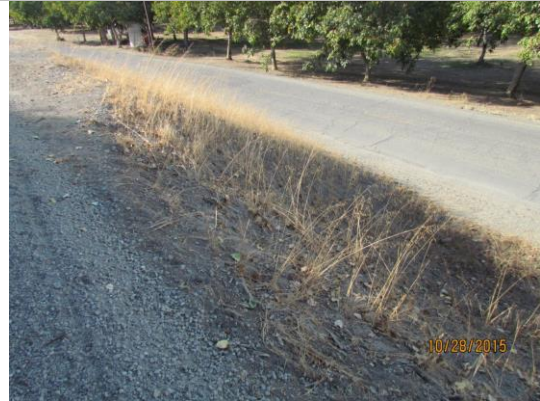
Photo 2 of 2 : SP_2017_RD1600_191_134_20170320_00085.jpg

The levee has a deep depression caused by removed tree. Fall 2013

View of the depression of the slope on the landward side of the levee looking downstream. Fall 2015.

| S1 : Repair slope instability. | | | | | | |

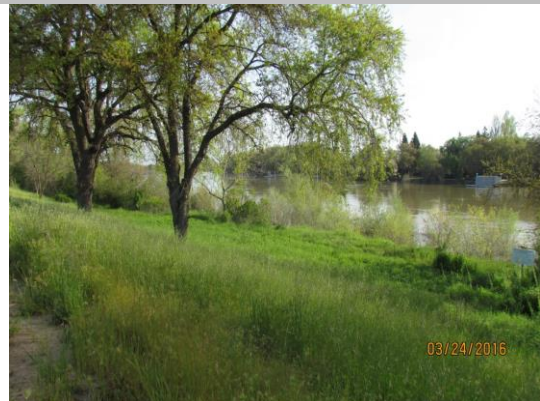
Photo 1 of 2 : SP_2017_RD1600_191_22_20170320_00024.jpg

View of the revegetation site at the berm edge on the waterward side of the levee looking upstream. Spring 2016.

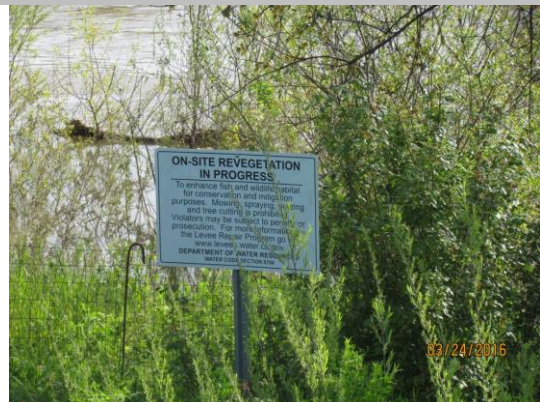
Photo 2 of 2 : SP_2017_RD1600_191_22_20170320_00025.jpg

Sign stating revegetation site. Spring 2016.

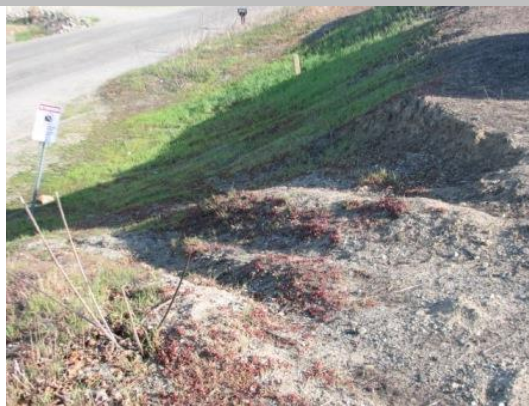
Photo 1 of 2 : SP_2017_RD1600_191_4_20170320_00007.jpg

| Damage looks like caused by vehicles. | | | | | |

Erosion from vehicles on levee slope. Spring 2013

| S3 : Repair the levee slope damaged by vehicle traffic and prevent access where possible. | | | | | |

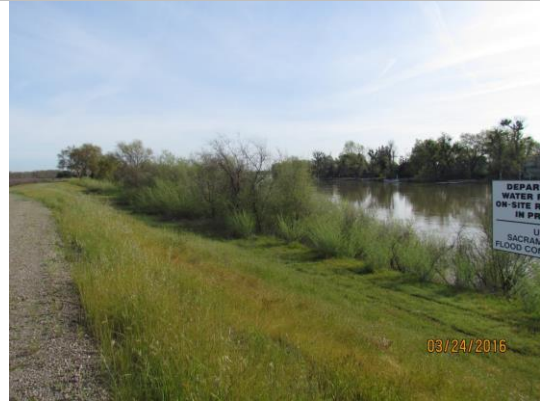
Photo 1 of 2 : SP_2017_RD1600_191_5_20170320_00009.jpg

View of the revegetation site on the berm of the waterward side of the levee looking upstream. Spring 2016.

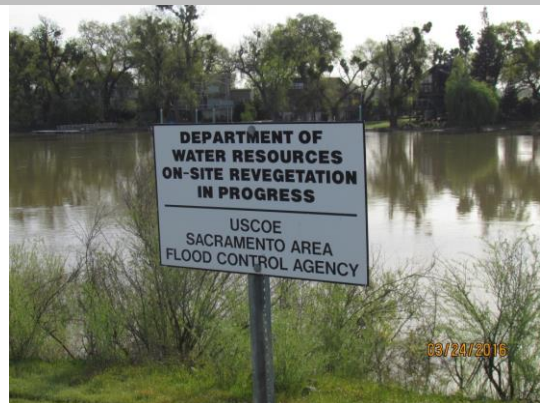
Photo 2 of 2 : SP_2017_RD1600_191_5_20170320_00010.jpg

DWR revegetation site. Spring 2016.

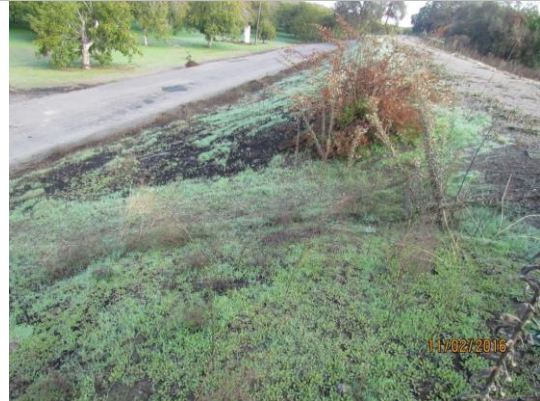
Photo 1 of 1 : SP_2017_RD1600_191_70_20170320_00072.jpg

View of slope instability due to vehicular activity. Fall 2016.

| S3 : Repair the levee slope damaged by vehicle traffic and prevent access where possible. | | | | | |

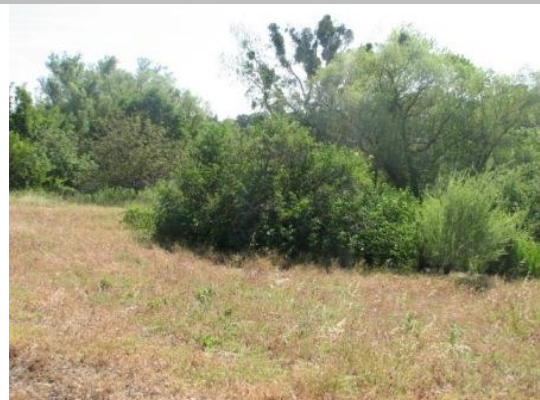
Photo 1 of 2 : SP_2017_RD1600_191_31_20170320_00038.jpg

A photo of a Elderberry bush in the area.

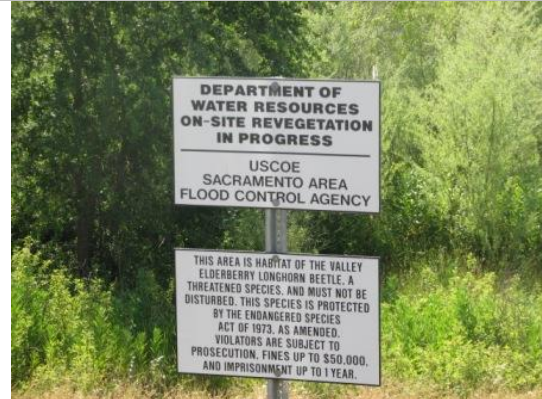
Photo 2 of 2 : SP_2017_RD1600_191_31_20170320_00039.jpg

Revegetation site with the Elderberry Beetle. Photo taken spring 2012.

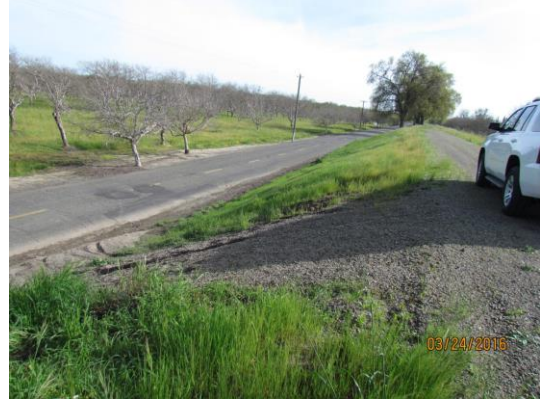
Photo 3 of 4 : SP_2017_RD1600_191_72_20170320_00076.jpg

| Erosion seems to be caused by rain runoffs. Slope is graveled. Unsure if it is being used as a ramp. | | | | | | |

Perspective view of the erosion on the landward side of the levee looking upstream. Spring 2016.

| E2 : Schedule repair of erosion site prior to the next inspection. | | | | | | |

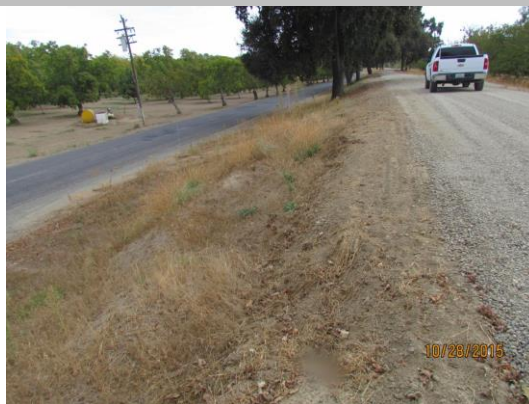
Photo 1 of 2 : SP_2017_RD1600_191_56_20170320_00060.jpg

View of the sloughing on the landward side of the levee looking upstream. Fall 2015.

| S1 : Repair slope instability. | | | | | |

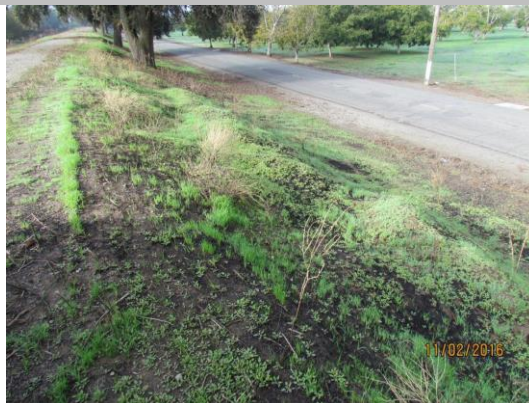
Photo 2 of 2 : SP_2017_RD1600_191_56_20170320_00061.jpg

Updated view of the sloughing on LS slope. Fall 2016.

| S1 : Repair slope instability. | | | | | | |

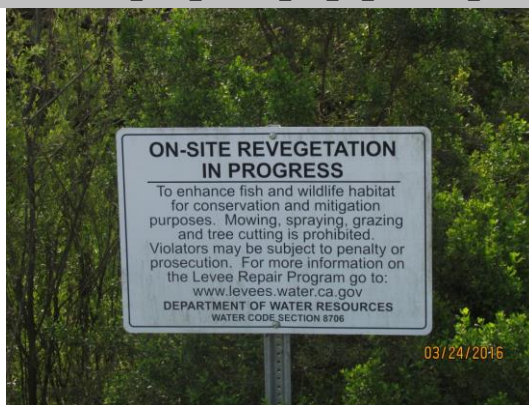
Photo 1 of 2 : SP_2017_RD1600_191_35_20170320_00040.jpg

Sign for revegetation site. Spring 2016.

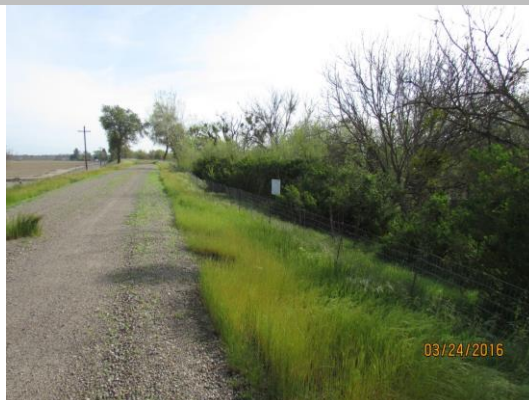
Photo 2 of 2 : SP_2017_RD1600_191_35_20170320_00041.jpg

View of the revegetation site on the waterward side of the levee looking upstream. Spring 2016.

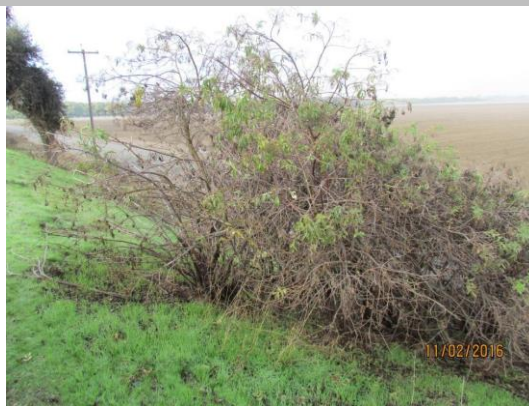
Photo 1 of 1 : SP_2017_RD1600_191_45_20170320_00049.jpg

Elderberry tree on landside slope. Fall 2016.

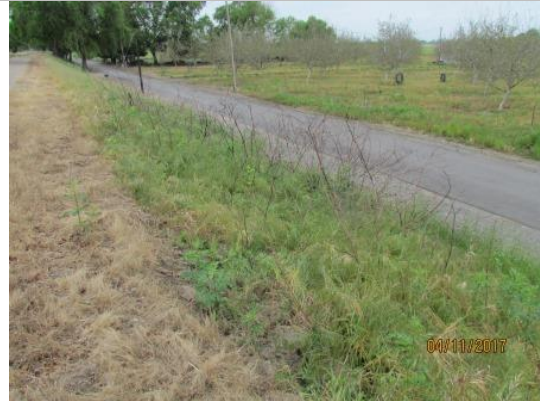
Photo 1 of 1 : SP_2017_RD1600_191_75_20170413_00127.jpg

Wild growth on landside levee slope. Spring 2017.

| Remove wild growth on landside levee slope. | | | | | |

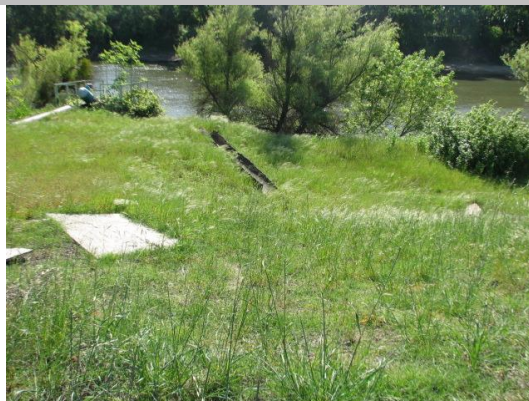
Photo 1 of 2 : SP_2017_RD1600_191_627_20170320_00091.jpg

| Some debris has been removed. Fall 2016. | | | | | |

Metal pipe and wood debris is on the waterside berm. Spring 2014

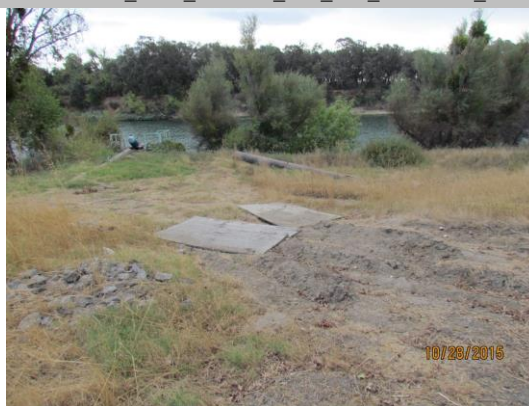
Photo 2 of 2 : SP_2017_RD1600_191_627_20170320_00092.jpg

| Some debris has been removed. Fall 2016. | | | | | | |

View of the metal pipe and wood debris on the berm of the waterward side of the levee. Fall 2015.

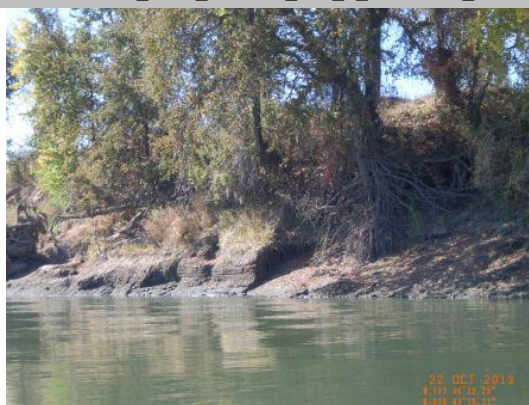
Photo 1 of 1 : SP_2017_RD1600_191_3_20170320_00006.jpg

| 1997 - Steep high bank. 2005 - Some small pockets in the low toe near the waterline. 2006 - Minor slope clearing. 2010 - Minor new erosion. 2011 - Multiple trees have fallen since last year. Some other trees look ready to fall. Significant new erosion since last year. 2012 - Minor new erosion. 2013 - Minor new erosion. 2015: New minor erosion at toe. [2015 Site ID: SAC 74-4 R] | | | | | |

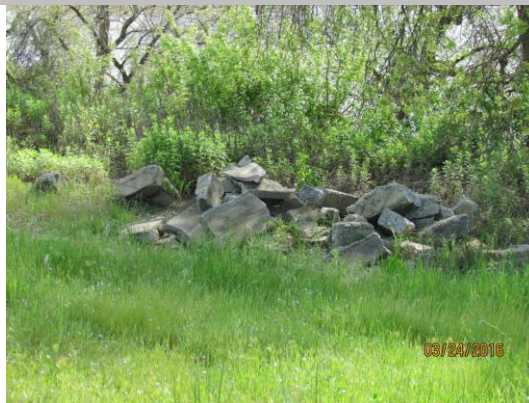
Photo 1 of 2 : SP_2017_RD1600_191_628_20170320_00093.jpg

View of the concrete pile on the berm of the waterward side of the levee. Spring 2016.

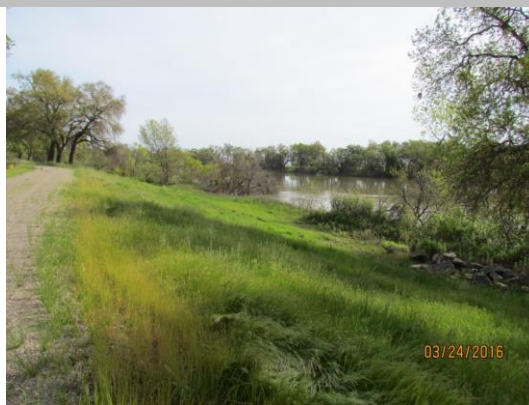
Photo 2 of 2 : SP_2017_RD1600_191_628_20170320_00094.jpg

Perspective view of the concrete pile looking upstream. Spring 2016.

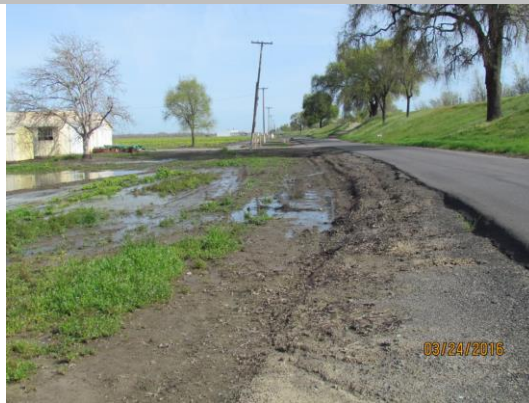
Photo 1 of 2 : SP_2017_RD1600_191_73_20170320_00077.jpg

| There appears to be a ponding issue and will have to be monitored during next inspection. | | | | | |

View of the seepage by the road looking upstream. Spring 2016.

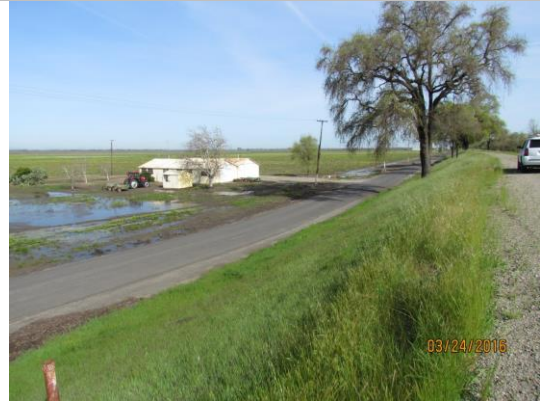
Photo 2 of 2 : SP_2017_RD1600_191_73_20170320_00078.jpg

| There appears to be a ponding issue and will have to be monitored during next inspection. | | | | | | |

View taken from the crown of the levee of the seepage. Spring 2016.

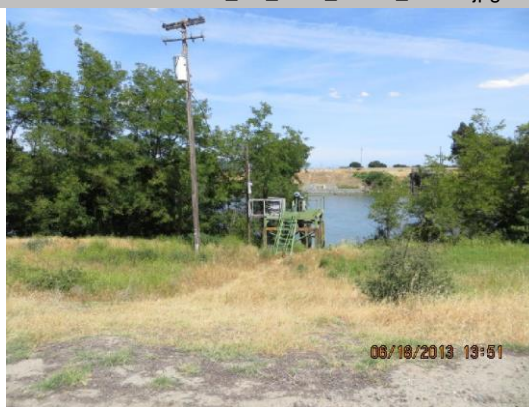
Photo 2 of 3 : UCIP_SP_2017_15125_24845.jpg

Slant pump on metal pier on WS berm.

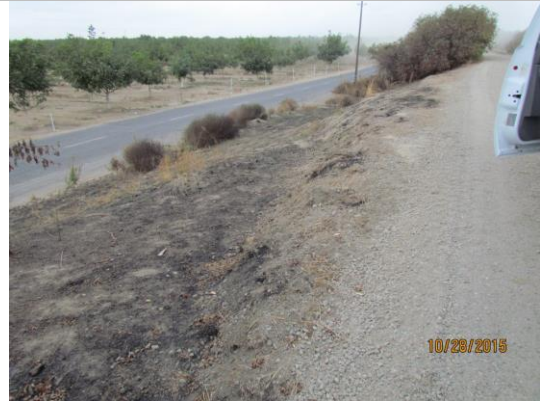
Photo 2 of 2 : SP_2017_RD1600_191_141_20170320_00087.jpg

View of the erosion on the landward side of the levee looking upstream.
Fall 2015.

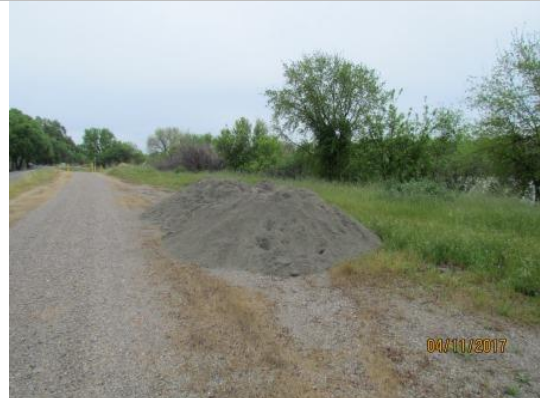
Photo 1 of 1 : SP_2017_RD1600_191_78_20170413_00129.jpg

| Sand pile on waterside levee shoulder. | | | | | |

View of sand pile on waterside levee shoulder. Spring 2017.

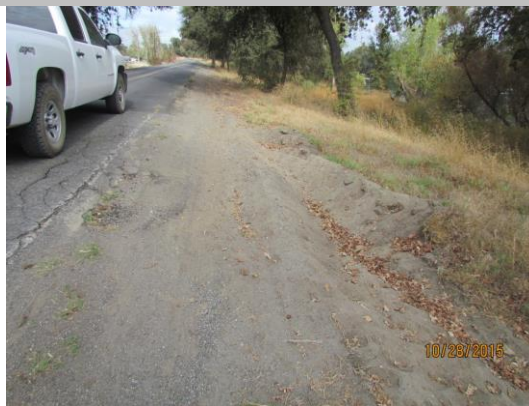
Photo 1 of 1 : SP_2017_RD1600_191_58_20170320_00063.jpg

View of the slope stability on the waterward side of the levee looking upstream. Fall 2015.

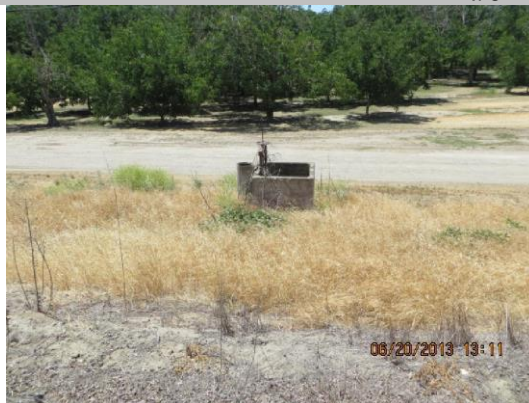
Photo 1 of 3 : UCIP_SP_2017_50101_25011.jpg

6'X6' concrete distribution box on LS toe.

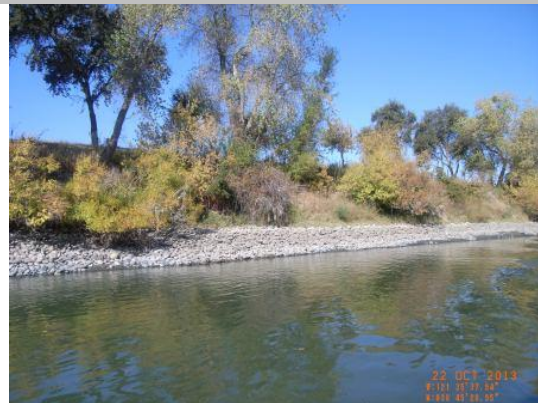
Photo 1 of 1 : SP_2017_RD1600_191_9_20170320_00014.jpg

| 2011 - Large vertical eroded face from a rotational failure just below pump. 2015: Does not meet criterial. [2015 Site ID: SAC_77-0_R] | | | | | |

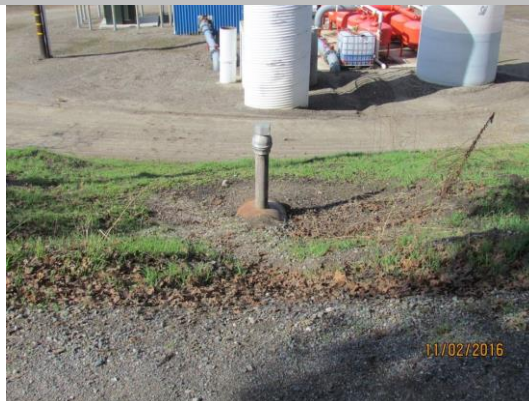
Photo 2 of 2 : SP_2017_RD1600_191_1199_20170320_00098.jpg

Updated view of the pipe with syphon breaker. Fall 2016.

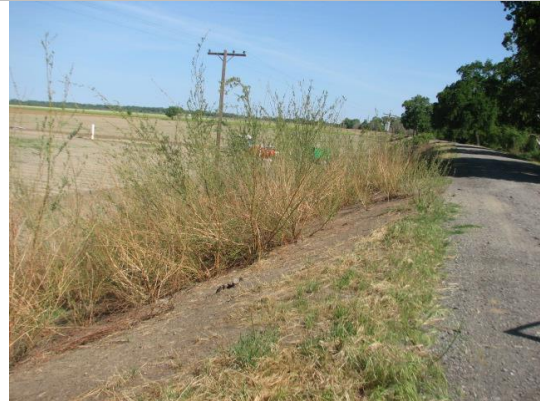
Photo 1 of 2 : SP_2017_RD1600_191_631_20170320_00095.jpg

The tall brush and vegetation blocks visibility. Spring 2014

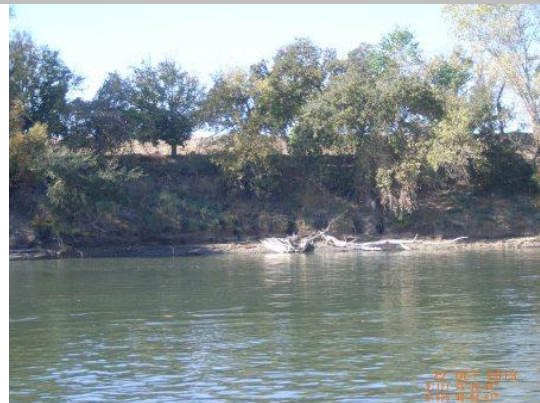
Photo 1 of 1 : SP_2017_RD1600_191_6_20170320_00011.jpg

| 2006 - Eddy scour off end of rock causing erosion and scour hole near levee. Sandy silt bank with rock on upstream end. 2010 - Trees are leaning more, minor new erosion. 2011 - Many of the tree roots have scoured out and trees look ready to fall. 2015: No observed changes. [2015 Site ID: SAC 77-7 R] | | | | | |

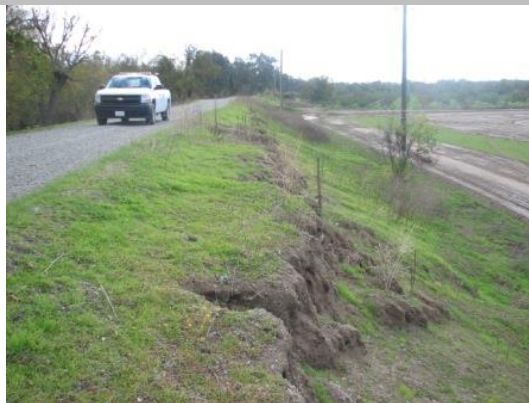
Photo 1 of 3 : SP_2017_RD1600_191_27_20170320_00028.jpg

The erosion appears to be moving closer to the shoulder.

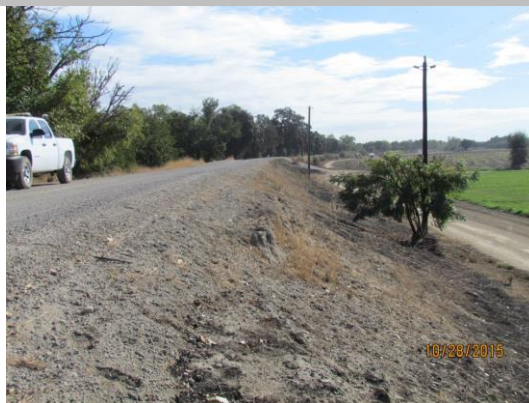
Photo 2 of 3 : SP_2017_RD1600_191_27_20170320_00029.jpg

The erosion seems to have been fixed. There still seems to be some erosion on the landward side of the levee looking downstream. Fall 2015.

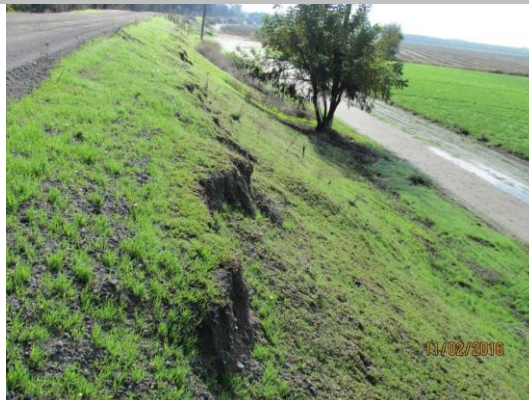
Photo 3 of 3 : SP_2017_RD1600_191_27_20170320_00030.jpg

Updated view of erosion site. Fall 2016.

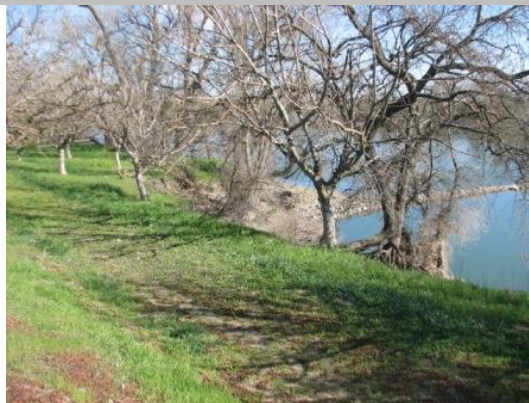
Photo 1 of 2 : SP_2017_RD1600_191_30_20170320_00036.jpg

Erosion is into the berm area and needs to be monitored. Spring 2013

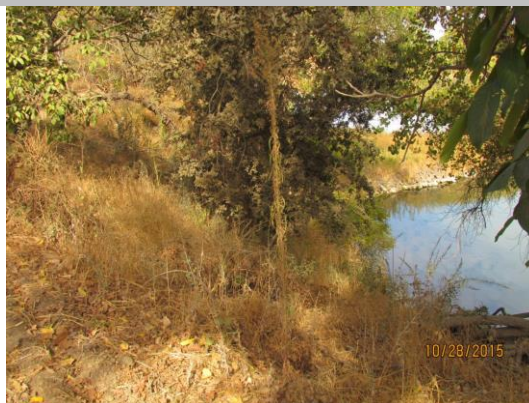
Photo 2 of 2 : SP_2017_RD1600_191_30_20170320_00037.jpg

View of the erosion into the berm area that needs to be monitored. Fall 2015.

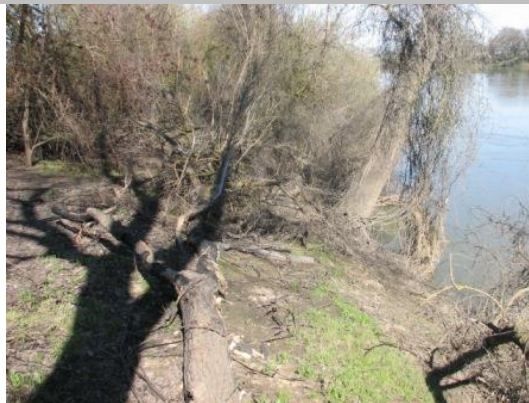
Photo 1 of 5 : SP_2017_RD1600_191_20_20170320_00016.jpg

| Erosion present at the berm, and it hasn't got into the levee prism yet. | | | | | |

This another view of the site.

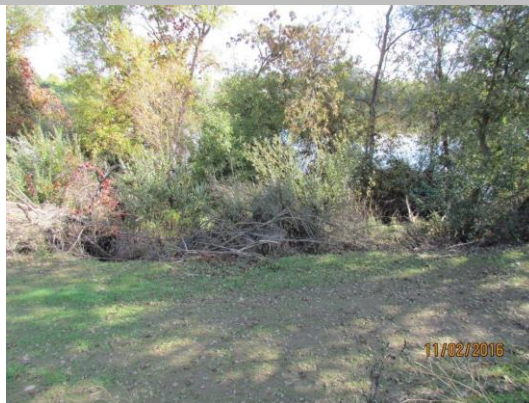
Photo 5 of 5 : SP_2017_RD1600_191_20_20170320_00020.jpg

| Erosion present at the berm, and it hasn't got into the levee prism yet. | | | | | | |

Updated view of erosion site. Fall 2016.

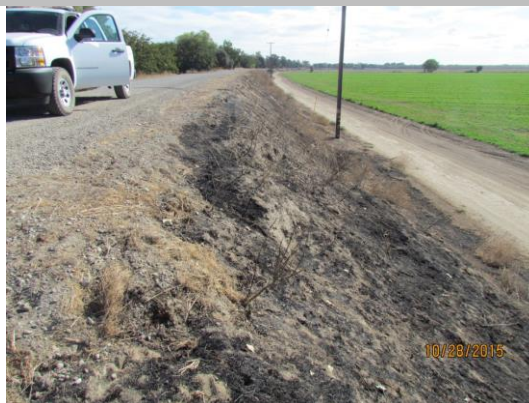
Photo 1 of 1 : SP_2017_RD1600_191_61_20170320_00066.jpg

View of the erosion on the landward side of the levee looking downstream. Fall 2015.

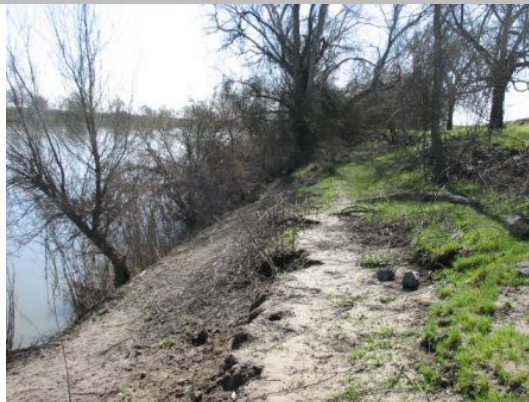
Photo 1 of 3 : SP_2017_RD1600_191_21_20170320_00021.jpg

The erosion is eroding away the berm area.

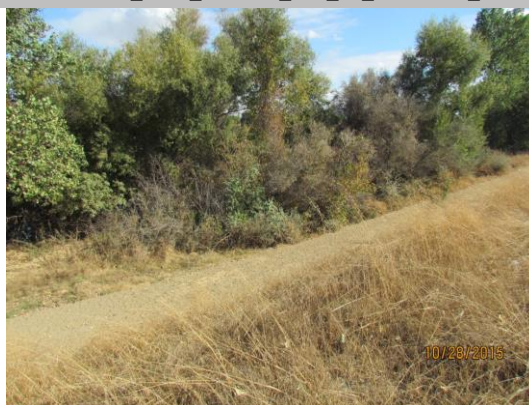
Photo 3 of 3 : SP_2017_RD1600_191_21_20170320_00023.jpg

View of the erosion along the waterward berm of the levee. Fall 2015.

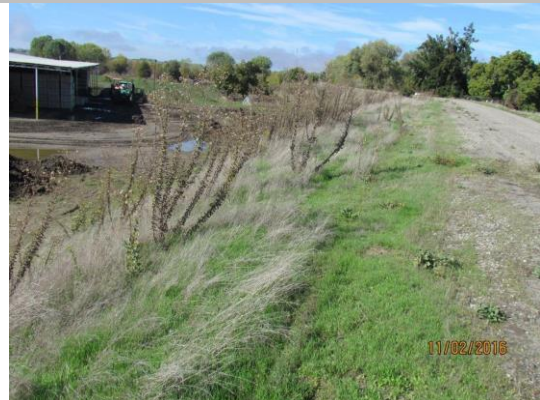
Photo 1 of 1 : SP_2017_RD1600_191_60_20170320_00065.jpg

Vegetation on LS slope partially blocks visibility. Fall 2016.

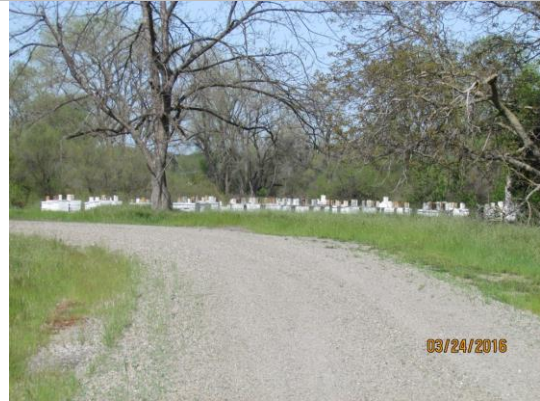
Photo 1 of 1 : SP_2017_RD1600_191_48_20170320_00051.jpg

View of the beehives on the waterward side of the levee looking upstream. Spring 2016.

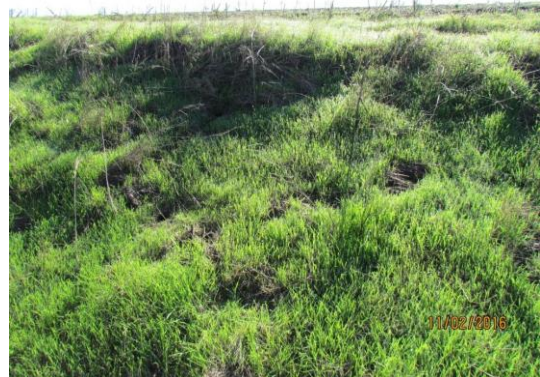
Photo 1 of 1 : SP_2017_RD1600_191_1200_20170320_00099.jpg

Rodent holes on waterside slope. Fall 2016.

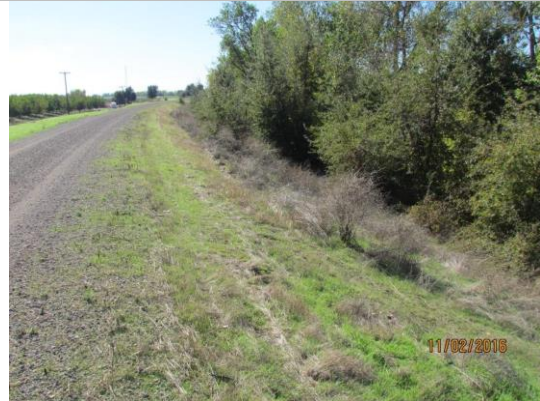
Photo 1 of 1 : SP_2017_RD1600_191_66_20170320_00069.jpg

| Only about 10 ft of WS slope cleared. | | | | | |

Vegetation on WS slope has been cleared only about 10 ft. from the crown. Fall 2016.

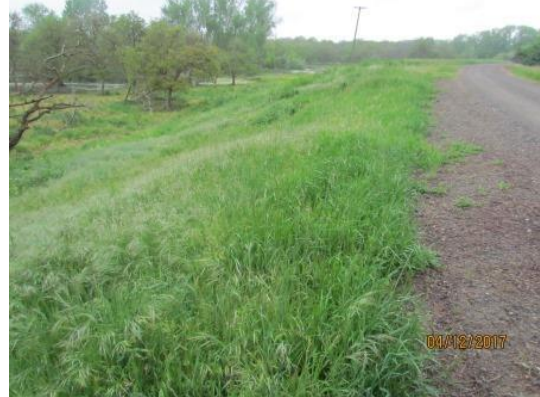
Photo 1 of 1 : SP_2017_RD1600_191_83_20170413_00131.jpg

Tall grass on landside levee slope, blocking visibility. Spring 2017.

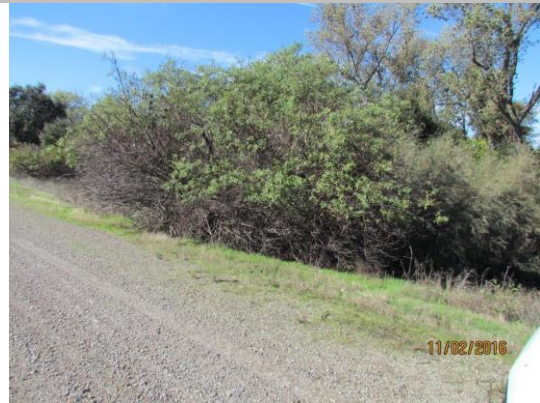
Photo 1 of 1 : SP_2017_RD1600_191_1201_20170320_00100.jpg

Elderberry tree on WS slope. Fall 2016.

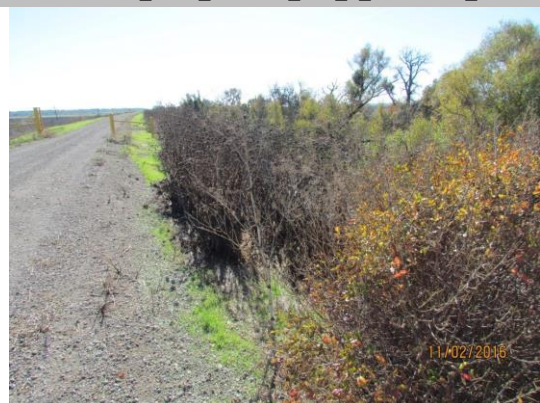
Photo 1 of 1 : SP_2017_RD1600_192_5_20170320_00004.jpg

View of vegetation on waterside slope. Fall 2016.

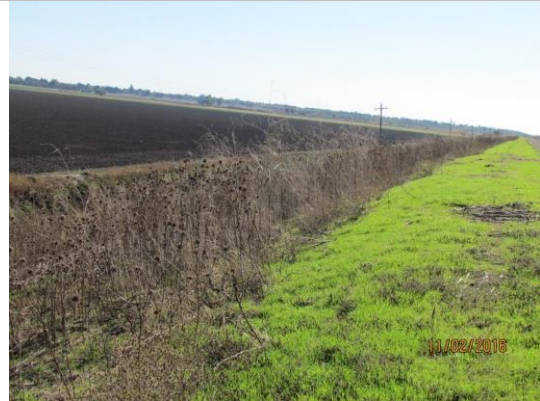
Photo 1 of 1 : SP_2017_RD1600_192_7_20170320_00007.jpg

View of vegetation on landside slope. Fall 2016.

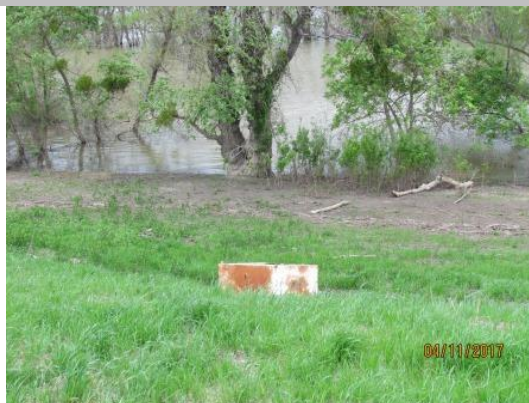
Photo 1 of 1 : SP_2017_RD1600_192_22_20170413_00031.jpg

| Refrigerator on waterside levee slope. | | | | | |

Refrigerator on waterside levee slope. Spring 2017.

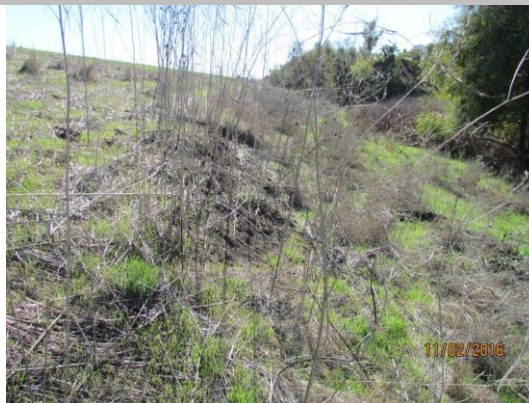
Photo 4 of 4 : SP_2017_RD1600_192_14_20170320_00015.jpg

Updated view of erosion site on WS slope. Fall 2016.

| E2 : Schedule repair of erosion site prior to the next inspection. | | | | | | |

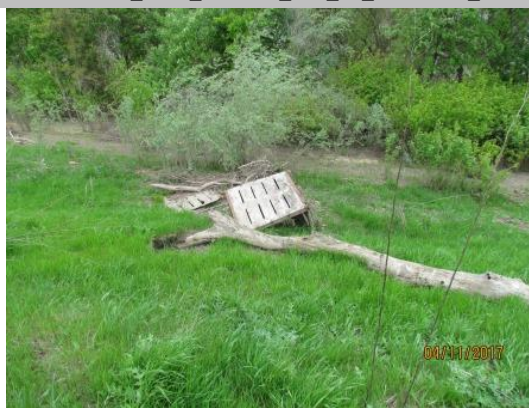
Photo 1 of 1 : SP_2017_RD1600_192_21_20170413_00030.jpg

| Trash and large log on watersid levee slope. | | | | | |

Trash on waterside levee slope. Spring 2017.

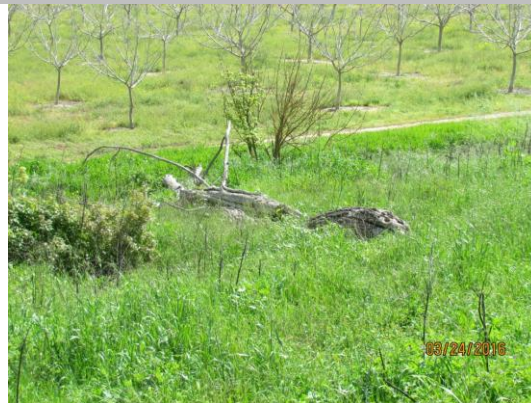
Photo 1 of 2 : SP_2017_RD1600_192_2_20170320_00001.jpg

A tree has fallen on the landward side of the levee. Spring 2016.

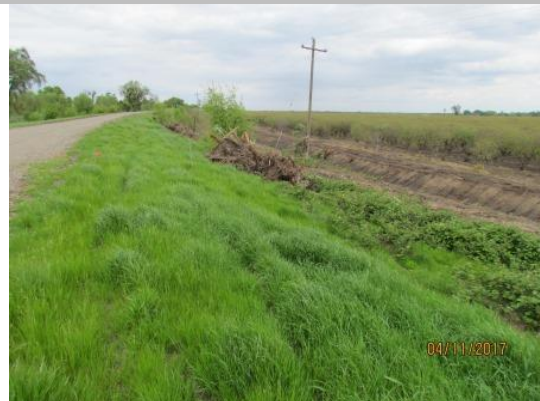
Photo 1 of 1 : SP_2017_RD1600_192_20_20170413_00029.jpg

| Mutiple pruning piles on landside levee slope. | | | | | |

Pruning piles on landside levee slope. Spring 2017.

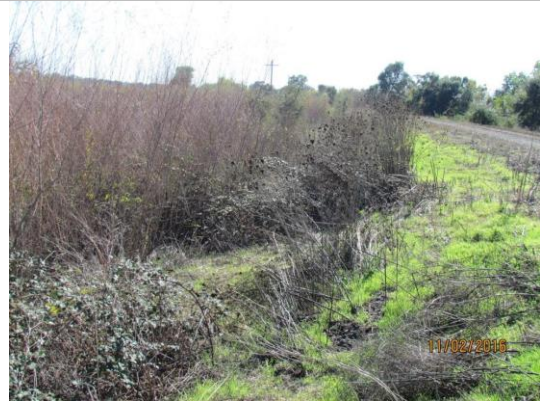
Photo 1 of 1 : SP_2017_RD1600_192_10_20170320_00009.jpg

| Only about 20 ft of LS slope cleared. | | | | | |

View of vegetation on landside slope. Only about 20 ft. from the crown has been cleared. Fall 2016.

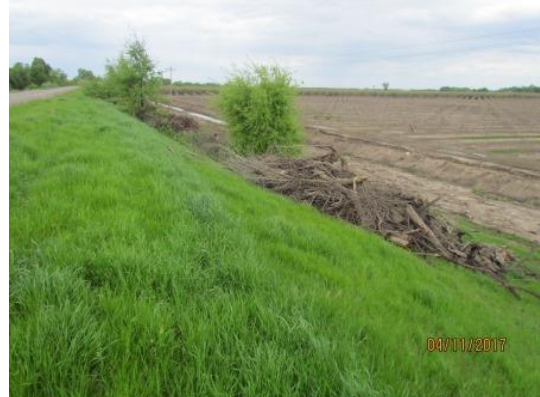
Photo 1 of 1 : SP_2017_RD1600_192_19_20170413_00028.jpg

| Multiple pruning piles on landside levee slope. | | | | | |

Pruning piles on landside levee slope. Spring 2017.

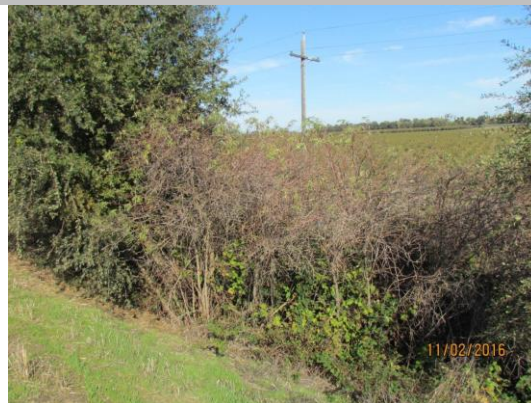
Photo 1 of 1 : SP_2017_RD1600_192_299_20170320_00019.jpg

Elderberry tree on landside slope. Fall 2016.

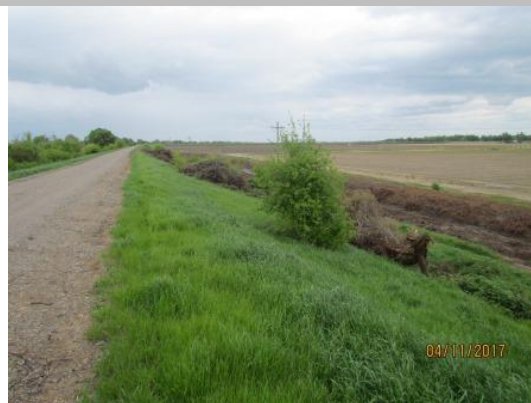
Photo 1 of 1 : SP_2017_RD1600_192_12_20170413_00027.jpg

| Multiple pruning piles on landside levee slope. | | | | | |

Pruning piles on landside levee slope. Spring 2017.

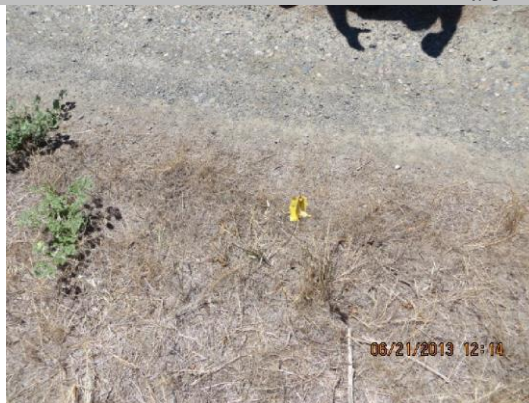
Photo 1 of 2 : UCIP_SP_2017_50099_27478.jpg

| FS_ID:50099 DS_ID:21501 EP_NO: 10944 Repair Type: Urgent Crossing Status: Indicator Found UCIP Comments: 08/16/2016 - unable to locate pipe. Need to install gas line markers on LS and WS of levee crown to denote location. (T. Hatch/UCIP)06/21/2013 - Need to install gasline markers on levee. (W. Wylie/UCIP) FIELD_STRUCT_DESC: 8.625-inch steel gas line through the levee, 2 feet below the crown (Permit No. 10944, 1976 - Shell Oil Company). [Additional Reference(s): DWR Levee Logs, 1988]. FS Date: 8/15/2016 | | | | | |

PG&E marker flag on Crown.

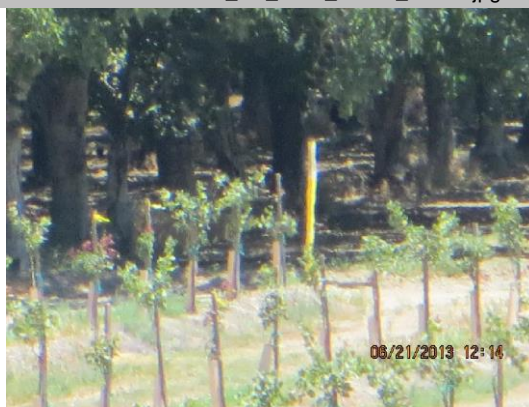
Photo 2 of 2 : UCIP_SP_2017_50099_27477.jpg

Carsonite gasline marker visible approximately 1,000-feet east of levee crown.

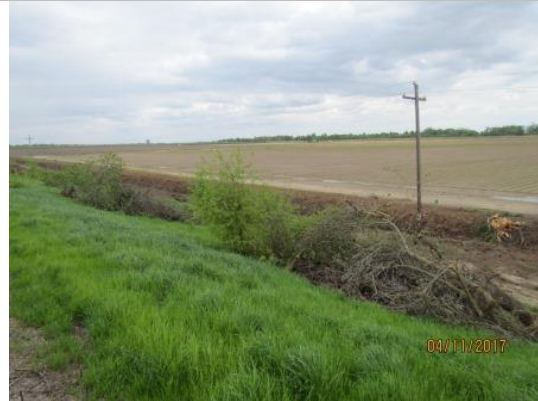
Photo 1 of 1 : SP_2017_RD1600_192_11_20170413_00026.jpg

| Prunings on landside levee slope. | | | | | |

Prunings on landside levee slope. Spring 2017.

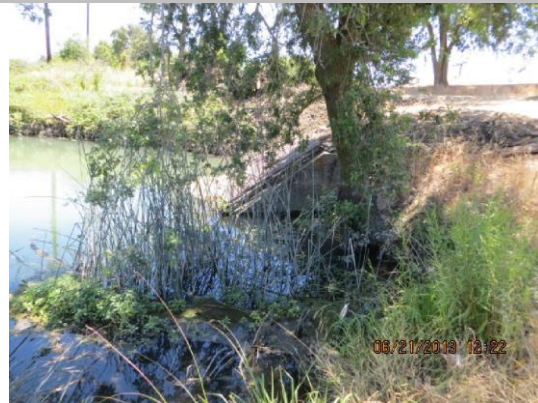
Photo 1 of 3 : UCIP_SP_2017_15303_25158.jpg

Concrete intake structure on LS.

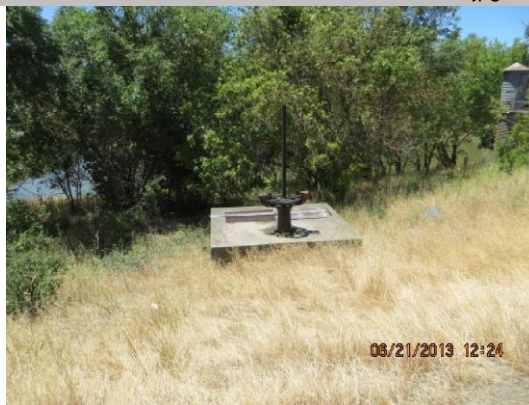
Photo 3 of 3 : UCIP_SP_2017_15303_25156.jpg

Slide gate in 9'X10' concrete box on WS slope.

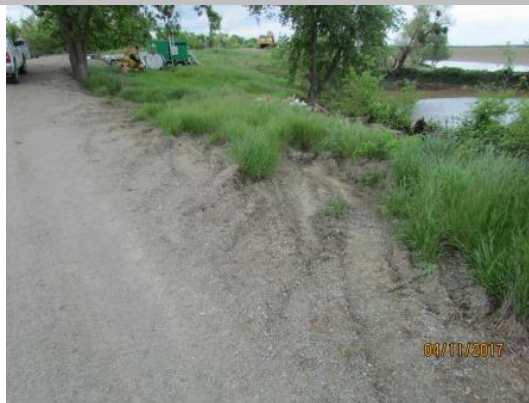
Photo 1 of 1 : SP_2017_RD1600_192_18_20170413_00025.jpg

| Vehicle tracks on landside levee slope. | | | | | | |

Vehicle tracks on landside levee slope. Spring 2017.

| S3 : Repair the levee slope damaged by vehicle traffic and prevent access where possible. | | | | | | |

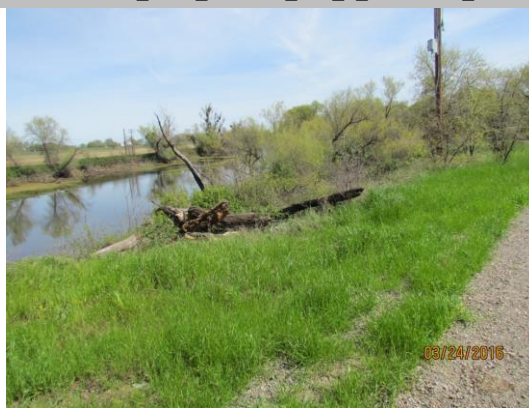
Photo 1 of 2 : SP_2017_RD1600_192_6_20170320_00005.jpg

View of the trees on the landward side of the levee looking downstream. Spring 2016.
